**PROPERTY CONDITION ASSESSMENT
OF
WORLD TRADE CENTER PORTFOLIO**

TWO WORLD TRADE CENTER

**Re: Due Diligence Physical Condition Survey
World Trade Center
New York, New York**

**REPORT OF
DUE DILIGENCE PHYSICAL CONDITION SURVEY
WORLD TRADE CENTER**

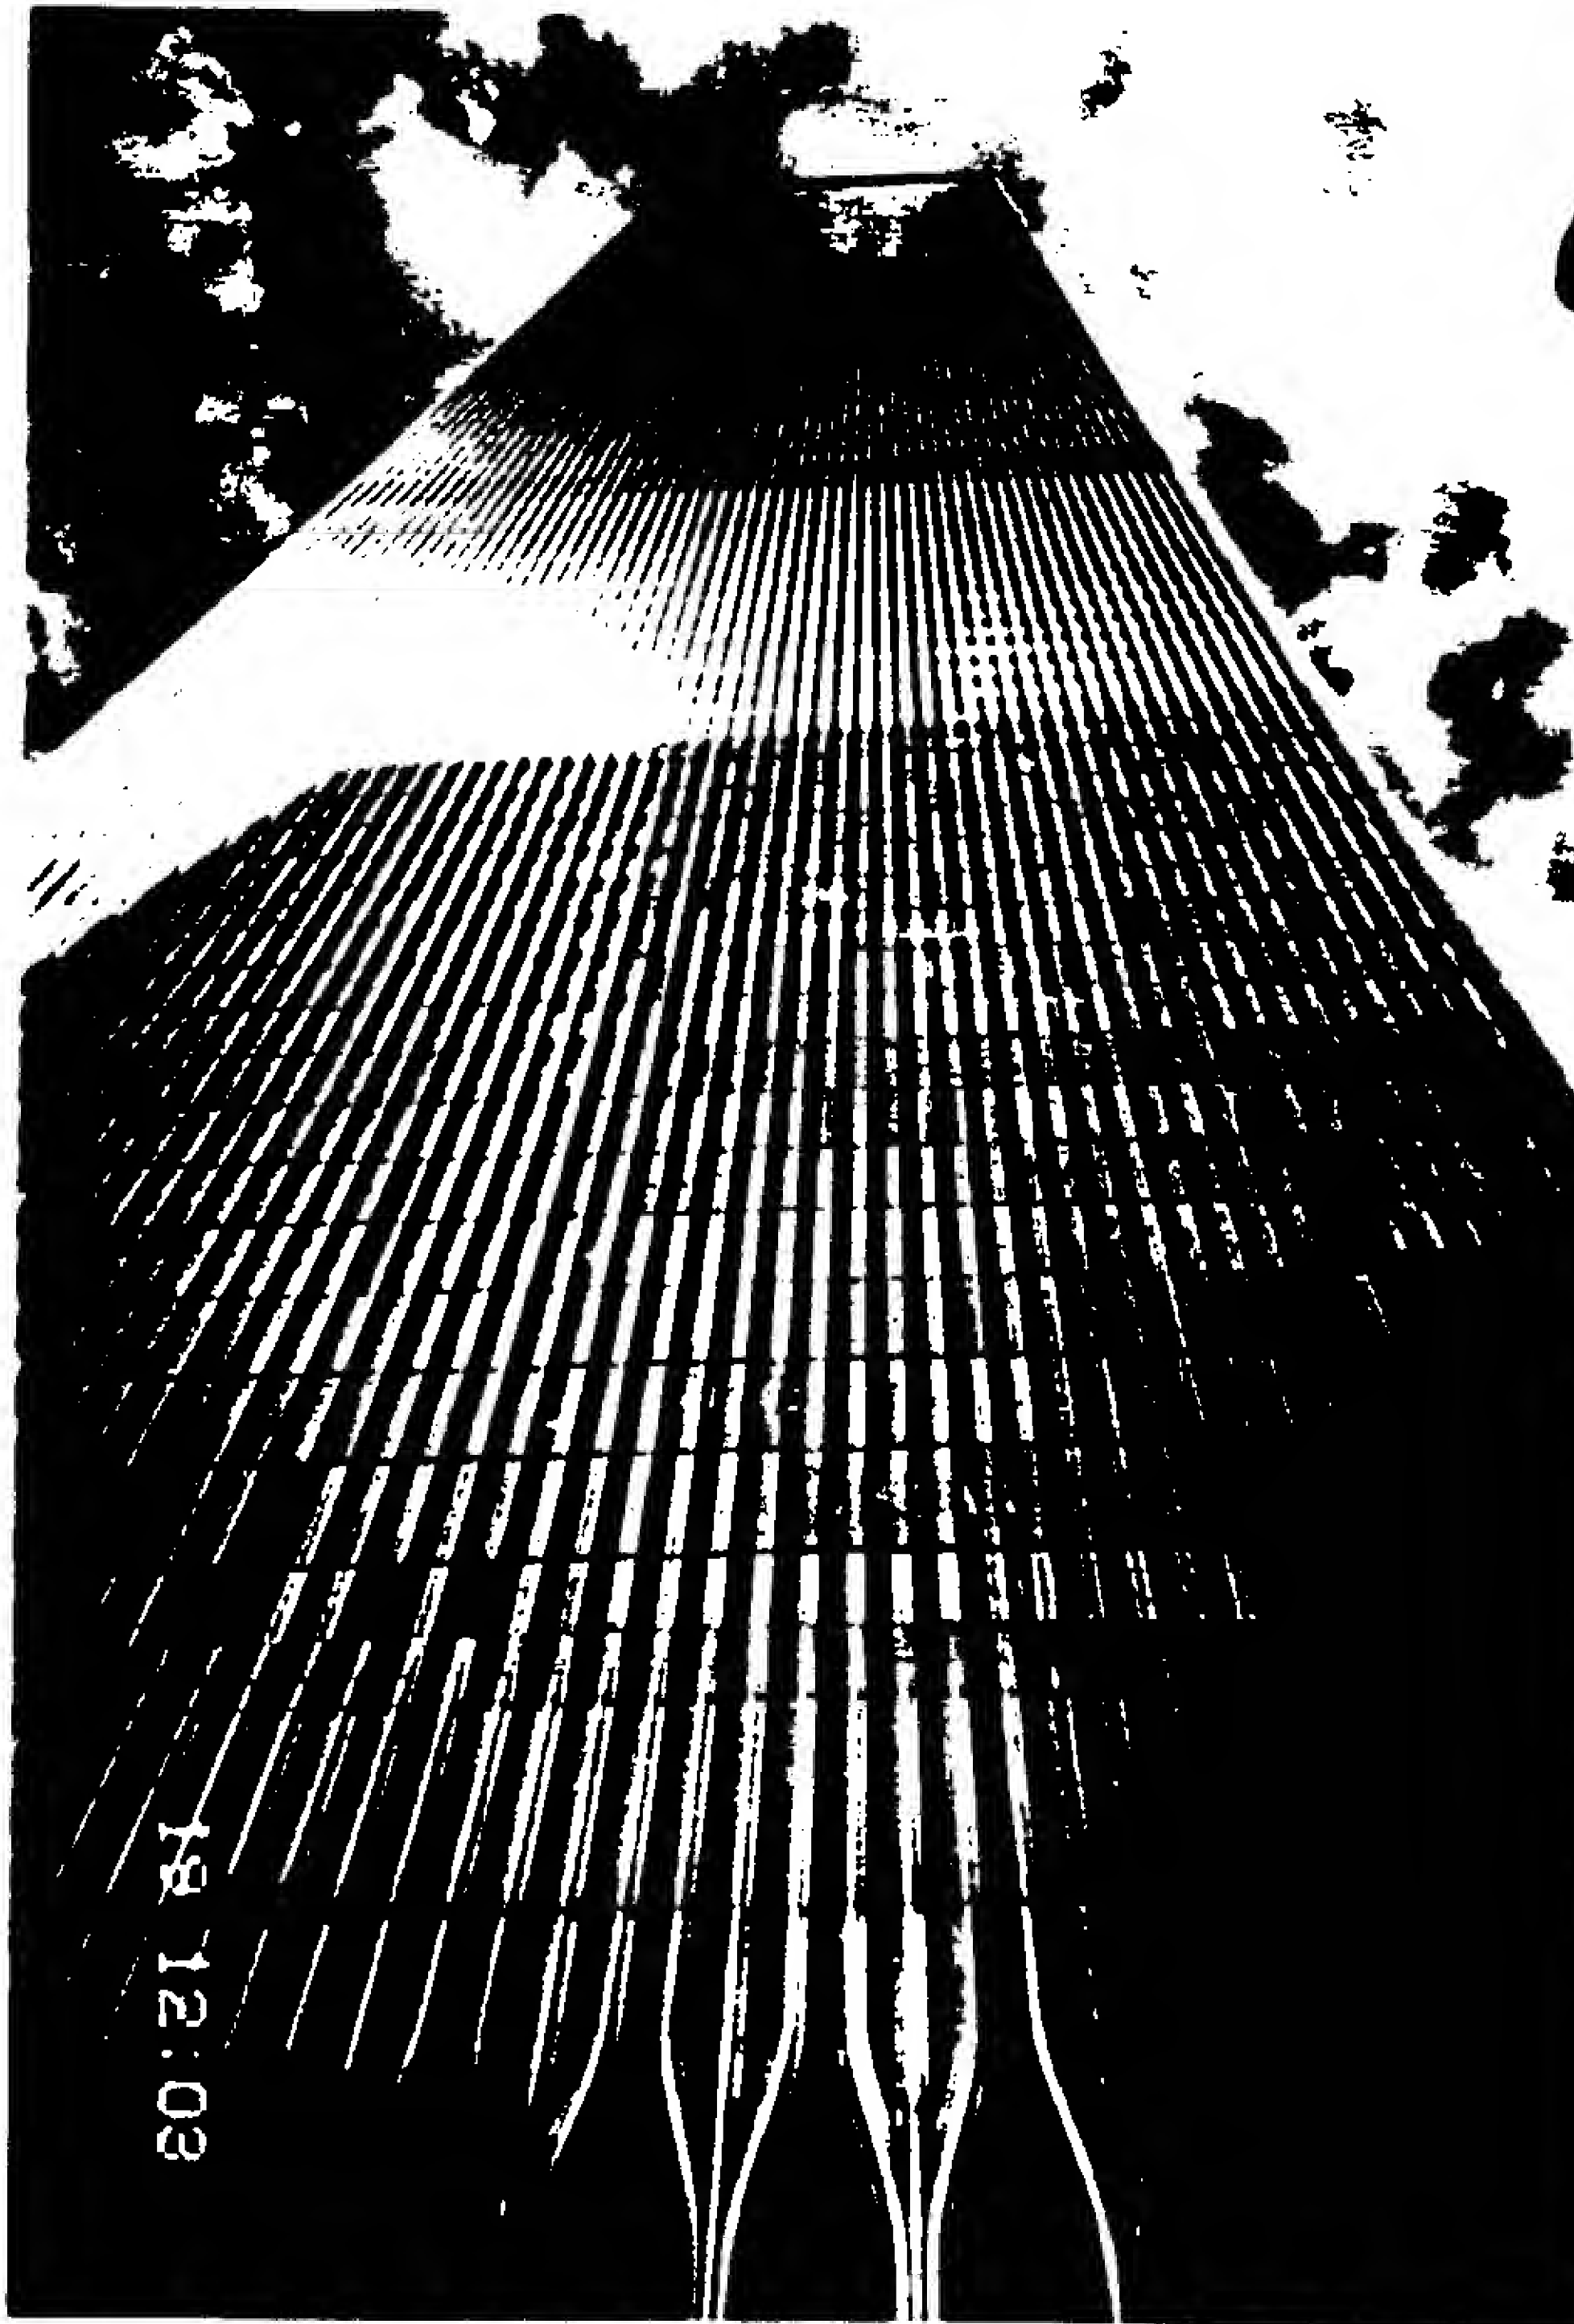
Photograph 1

Liberty Street
elevation

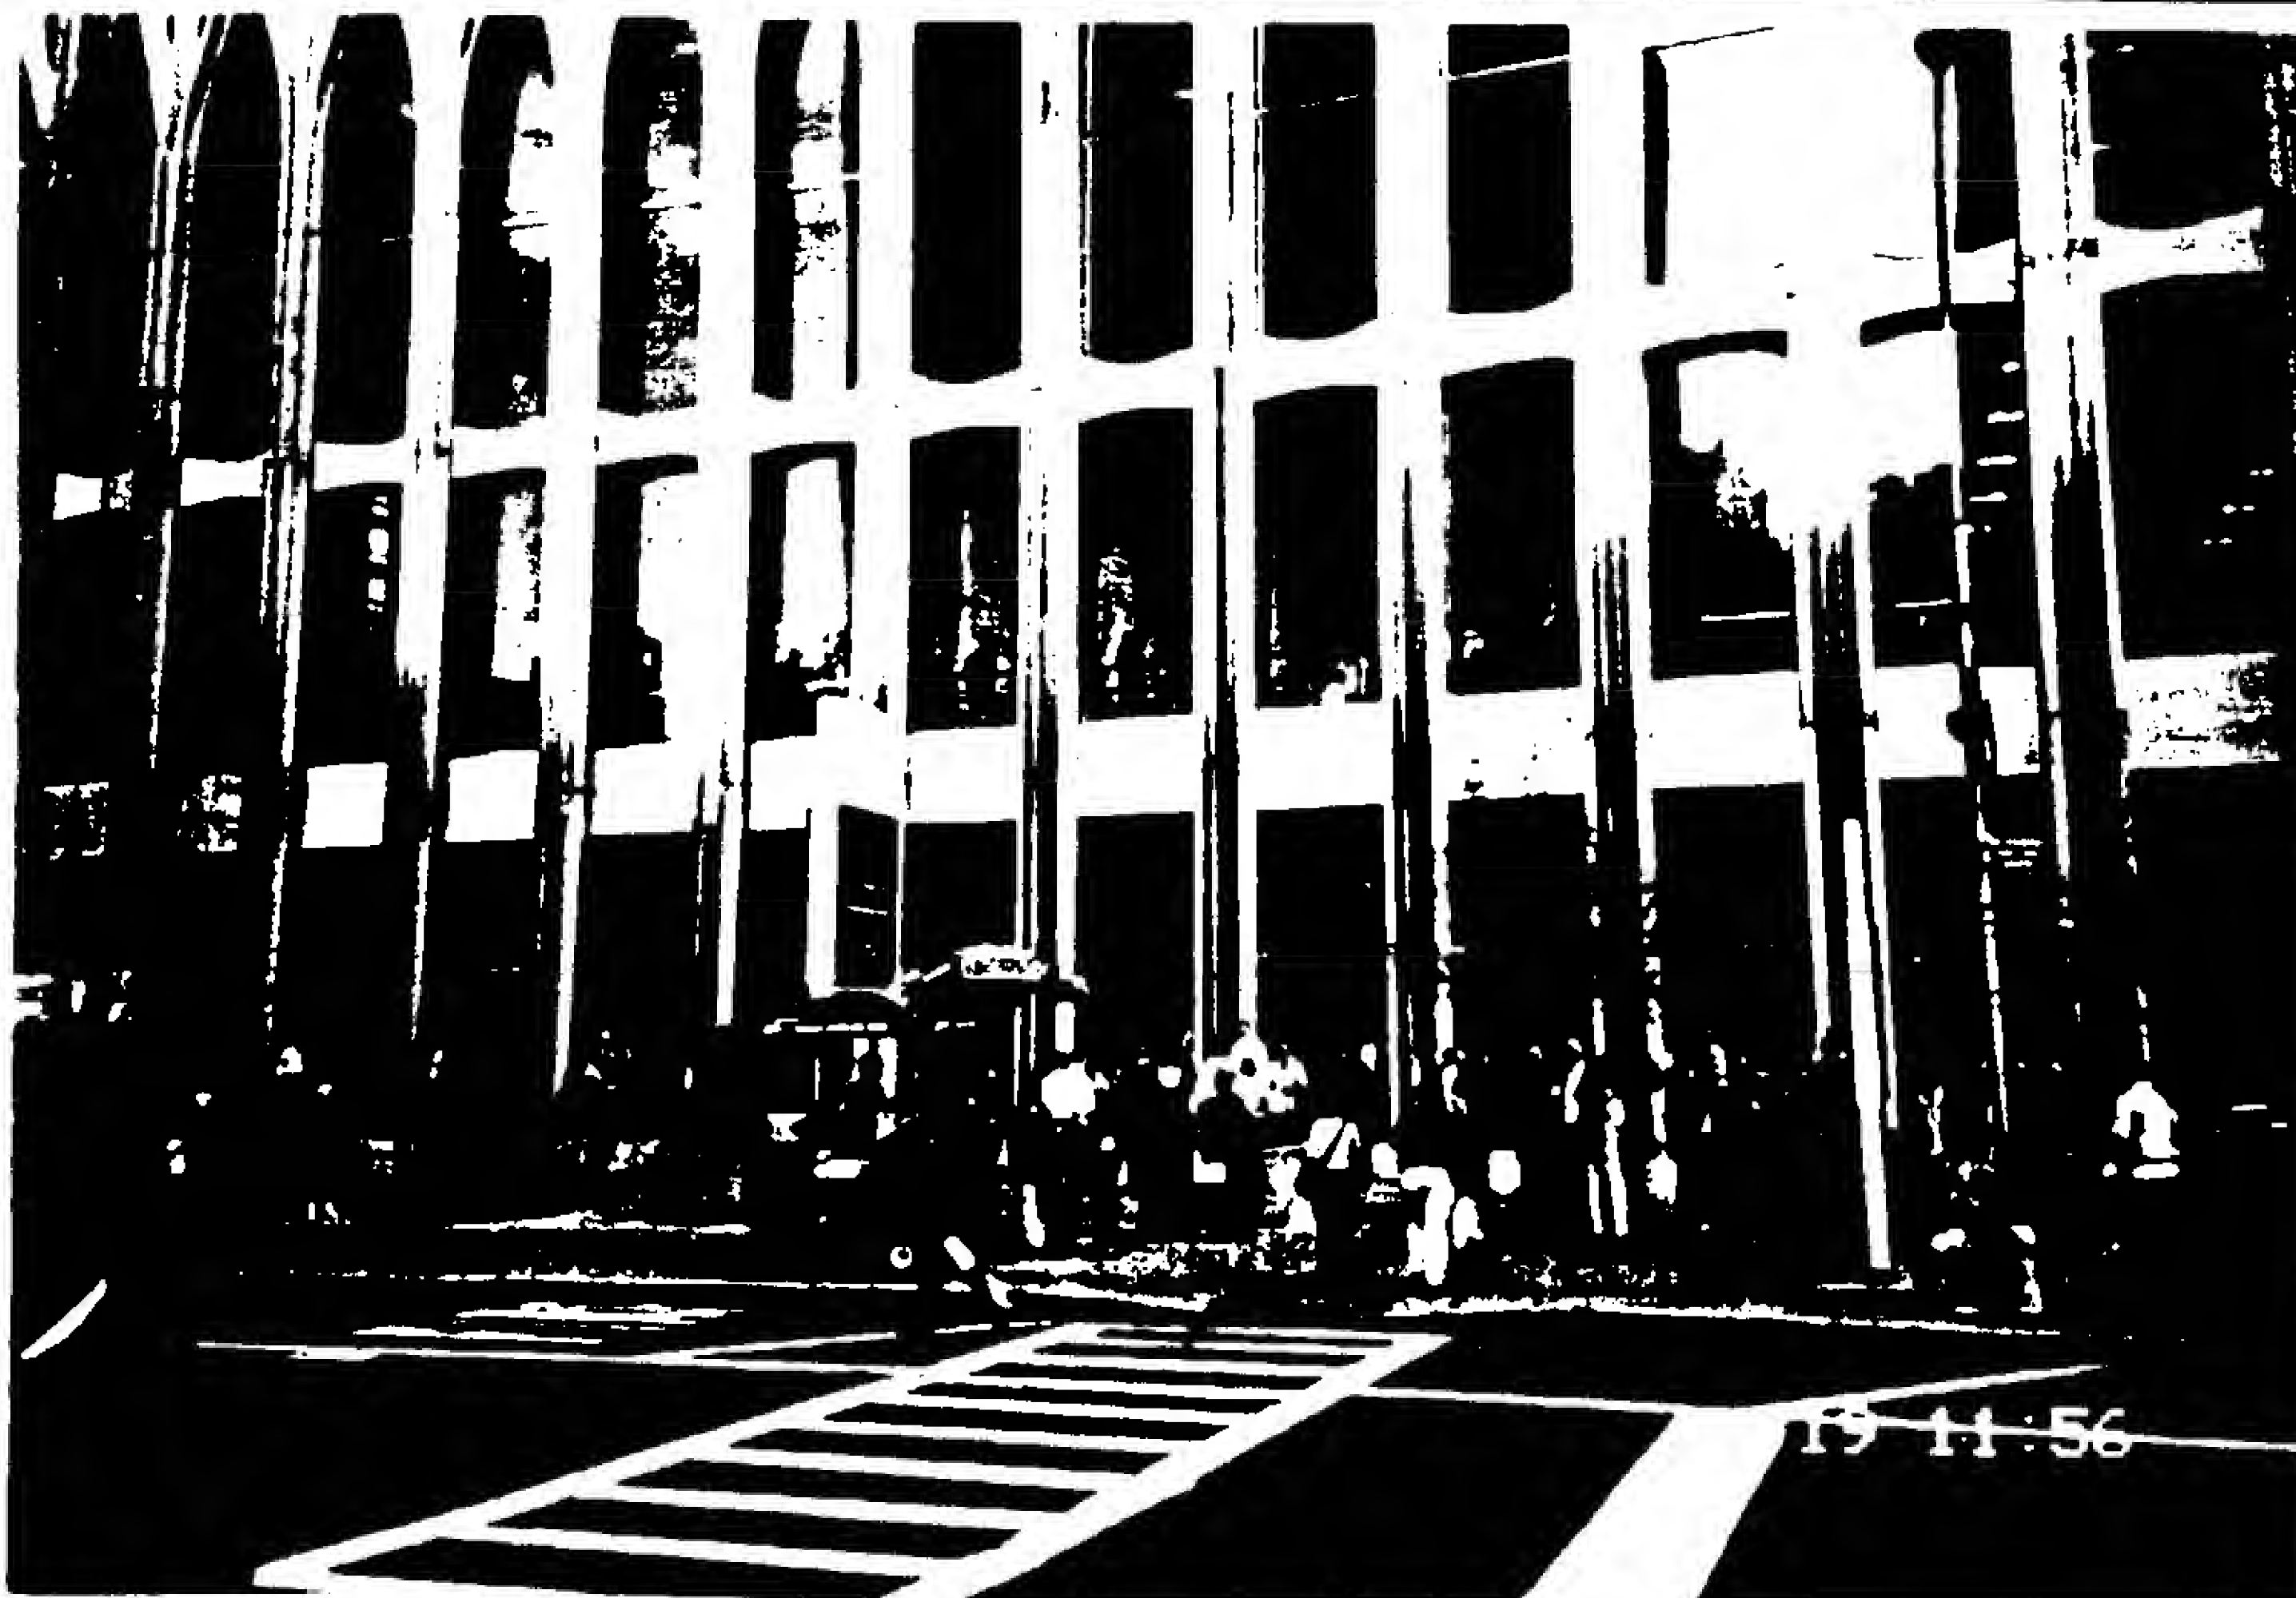
Photograph 2

Liberty Street
entrance to Lobby

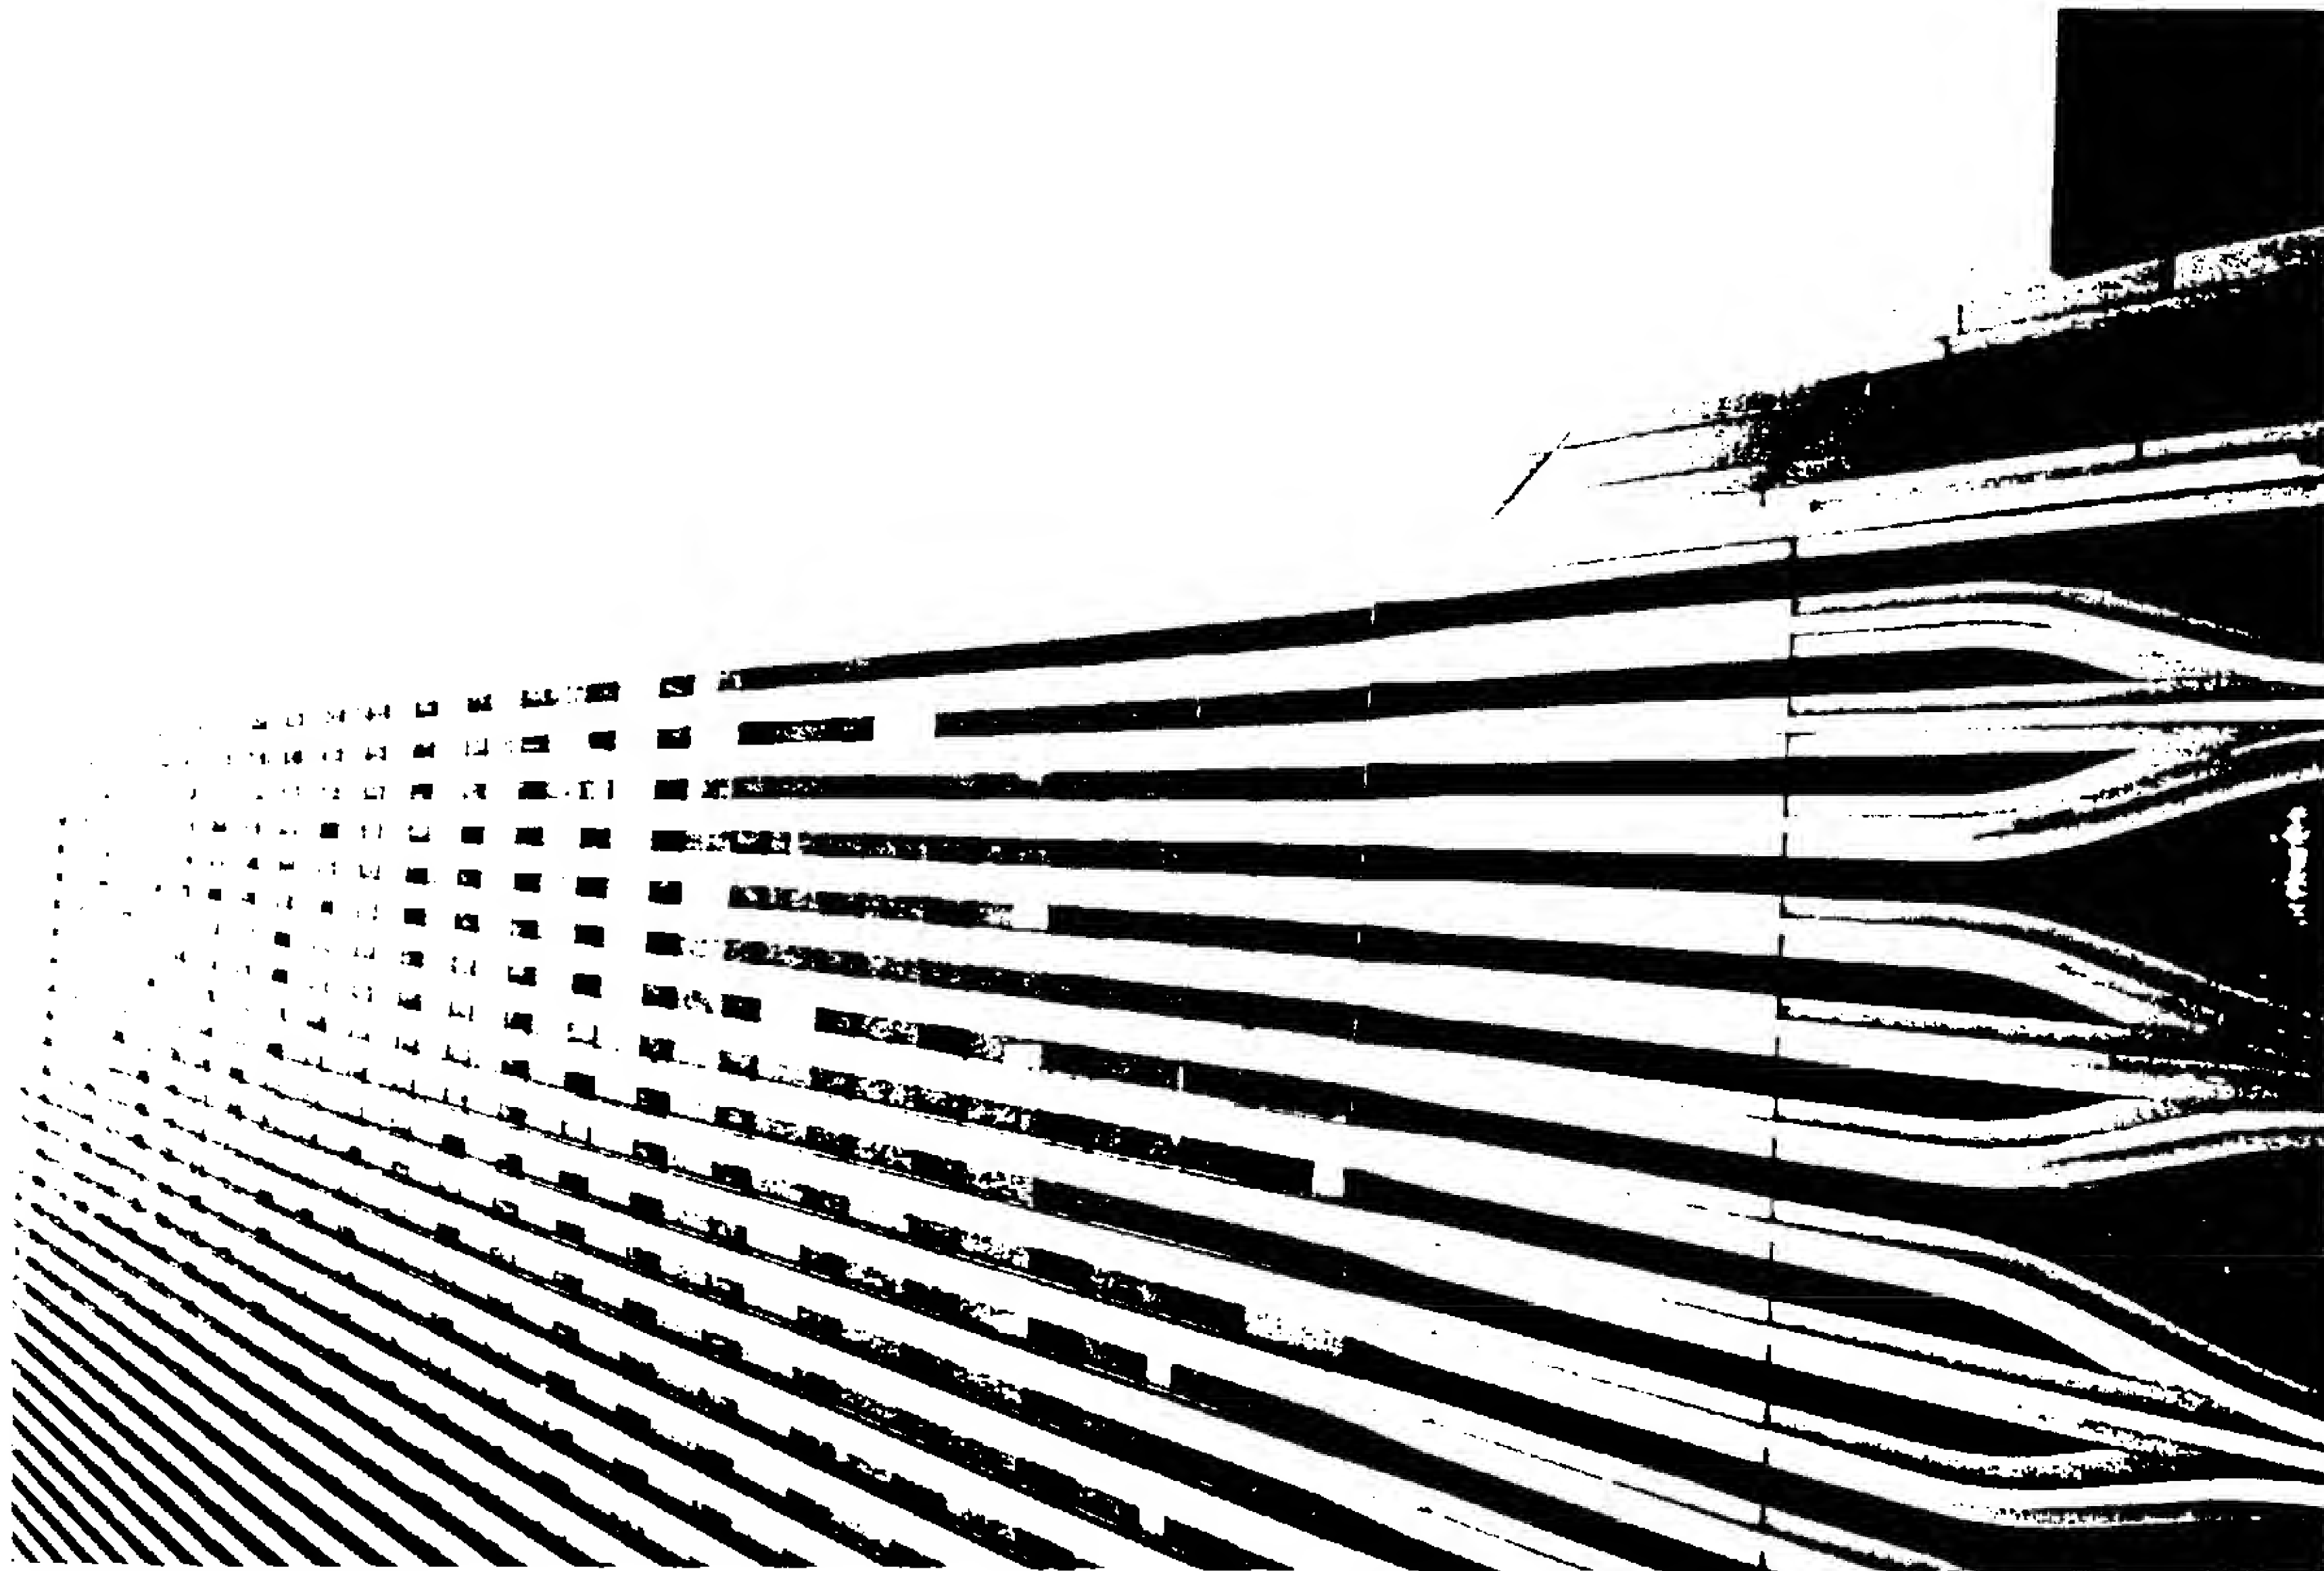
1

- B. The curtain wall system consists of vertical strip windows set between tightly spaced aluminum clad building columns (Refer to photographs 1, 2 and 3). Within the vertical strip windows, aluminum spandrel panels occur at each floor line. Aluminum panels are used to clad the four chamfered corners of the tower and the sloped parapet of the main roof (Refer to photograph 3). The finish on the curtain wall framing, aluminum column cladding, corner panels and parapet panels is a clear or natural anodize. The finish on the spandrel panels is darker and could be a light bronze anodized finish.
